SUPPLEMENTAL DRAFT ENVIRONMENTAL IMPACT STATEMENT BLUESTONE DAM SAFETY MODIFICATION

VOLUME III: APPENDICES H through L

Supplemental Draft Environmental Impact Statement, Bluestone Dam Safety Modification, Hinton, West Virginia

U.S. Army Corps of Engineers Huntington District Huntington, West Virginia

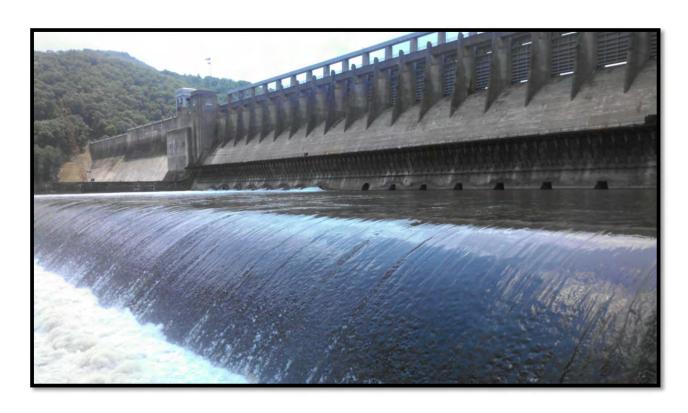
Photograph 1: Bluestone Dam (Reconnaissance Area 1).

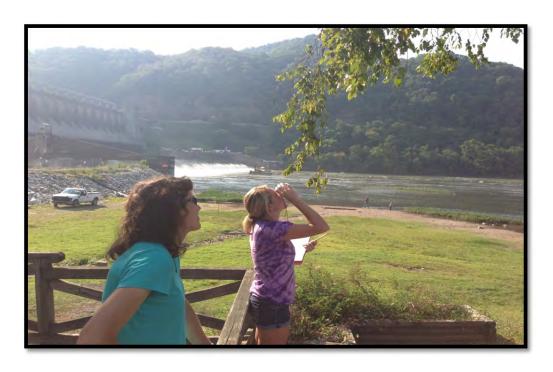
Photograph 5: The Service measuring tree height with a clinometer (Reconnaissance Area 1).

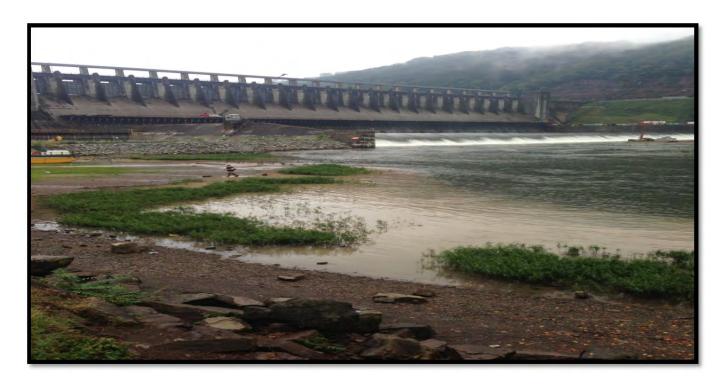
Photograph 6: Overview of Bluestone Dam (Reconnaissance Area 1).

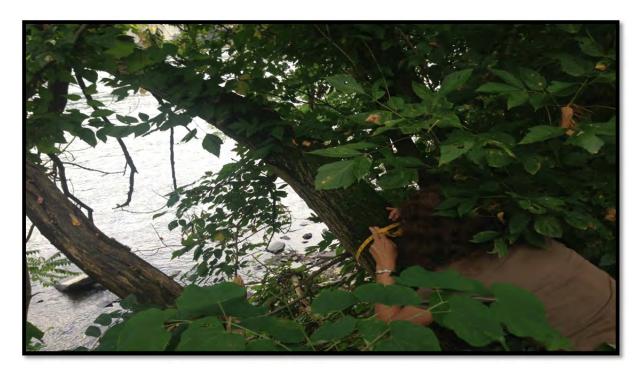
Photograph 10: The Service measuring diameter at breast height for HEP (Reconnaissance Area 1).

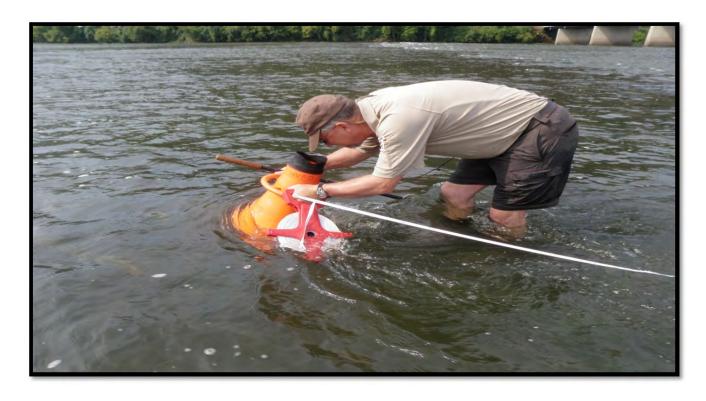
Photograph 11: The Service categorizing substrate type in the tailwaters (Reconnaissance Area 1).

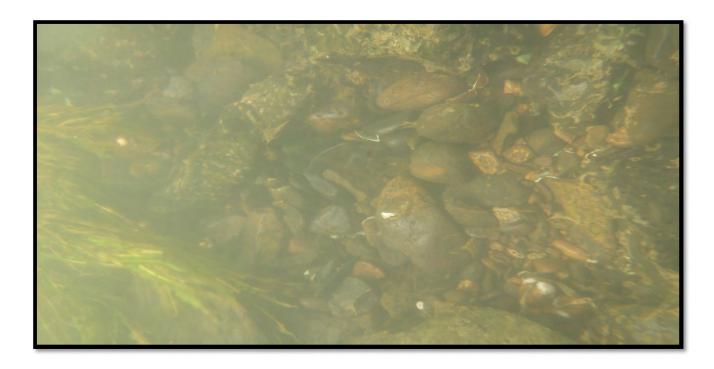
Photograph 12: Gravel and rubble substrate from the tailwaters (Reconnaissance Area 1).

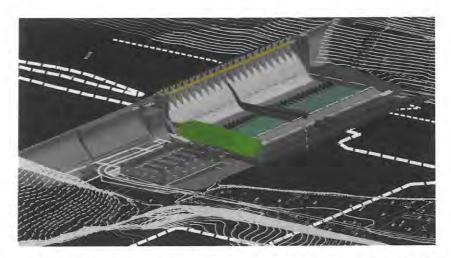
Figure 2. 3D Diagram of the Hydraulic Jump Basin with Supercavitating Baffles Alternative.

The stilling basin is anticipated to be constructed in two phases. In order to modify the stilling basin, temporary construction barriers (coffer cells) will be put in place to minimize impacts to downstream habitat. A permanent divider wall will be constructed to segregate the basin in two halves so that 8 of the 16 dam sluice gates will be operational at all times during construction.

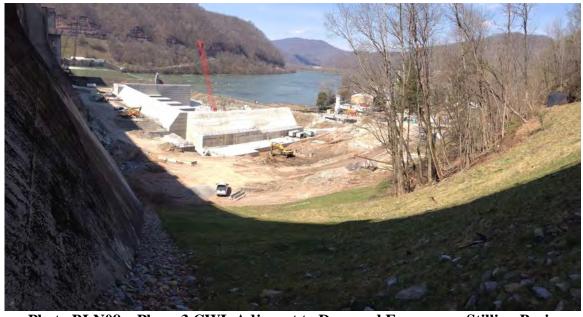
Photo BLN08 – Phase 3 CWL Adjacent to Dam and Emergency Stilling Basin Downstream Right Bank 24 March 2016

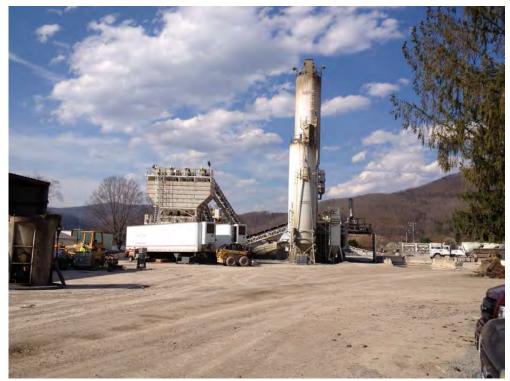
Photo BLN11 – Phase 3 Contractor's Concrete Plant Downstream Right Bank 24 March 2016

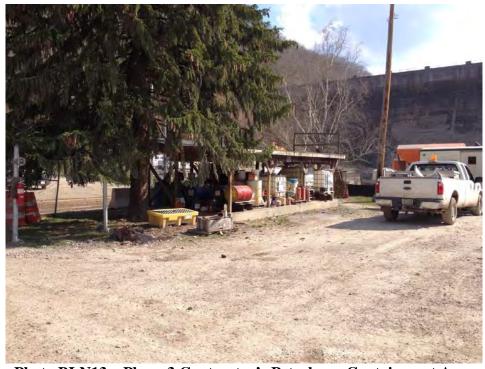
Photo BLN13 – Phase 3 Contractor's Petroleum Containment Area Downstream Right Bank 24 March 2016

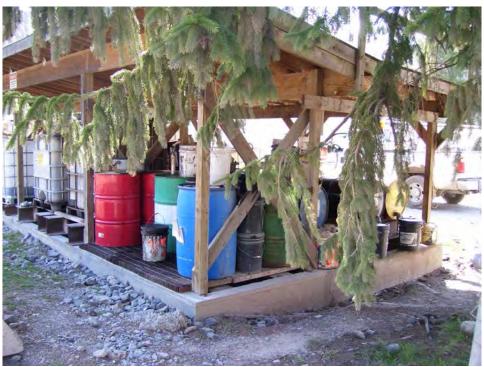
Photo BLN14 – Phase 3 Contractor's Petroleum Containment Area Downstream Right Bank 24 March 2016

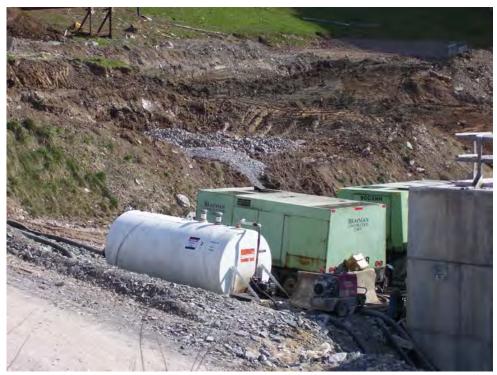
Photo BLN15 – Phase 3 Contractor Diesel AST Adjacent to Emergency Stilling Basin Downstream Right Bank 24 March 2016

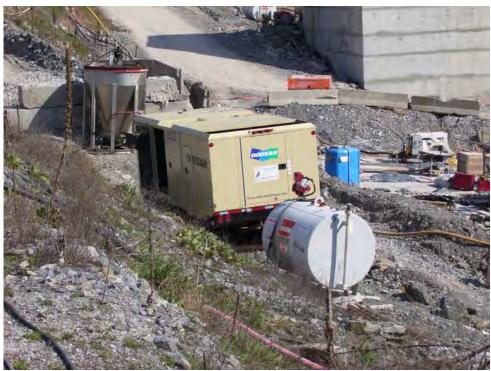
Photo BLN16 – Phase 3 Contractor Diesel AST Adjacent to Emergency Stilling Basin Downstream Right Bank 24 March 2016

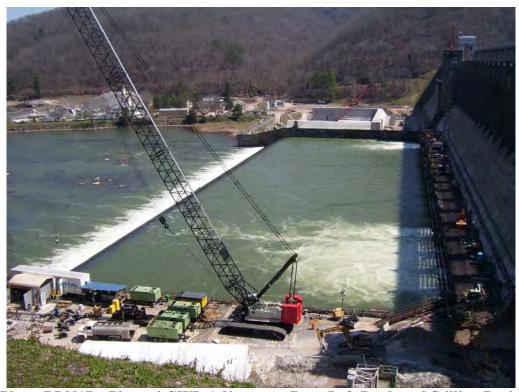
Photo BLN17 – Phase 4 CWL Adjacent to Dam Left Bank and Stilling Basin 24 March 2016
